# Glass Fiber Reinforced Polymer Dowel Bar Evaluation

WA-RD 795.1

## Post-Construction Report Experimental Feature 10-04

I-5, Contract 7753, SR 532 Vic. to Starbird Rd Vic. – PCCP Rehab.

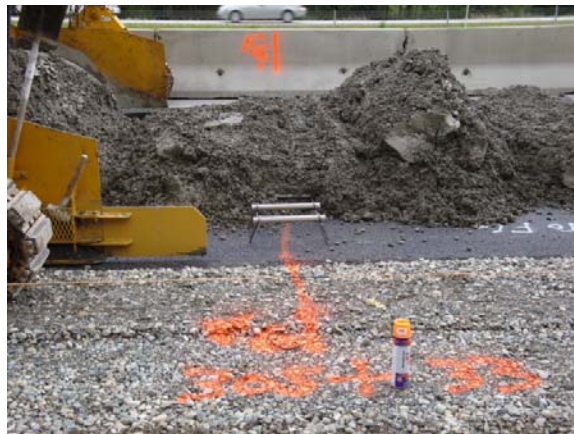
Figure 3. GFRP dowels used in new construction on I-5.

Standard construction practices were employed on all three projects as shown in the photos (Figures 3 through 13). MMFX dowel bars were used on the Starbird Road project as the control section. Epoxy coated dowel bars meeting ASTM A 934 (purple) were used on the two DBR projects. No construction problems were reported on the I-5 or the I-82, Grandview to Prosser projects.

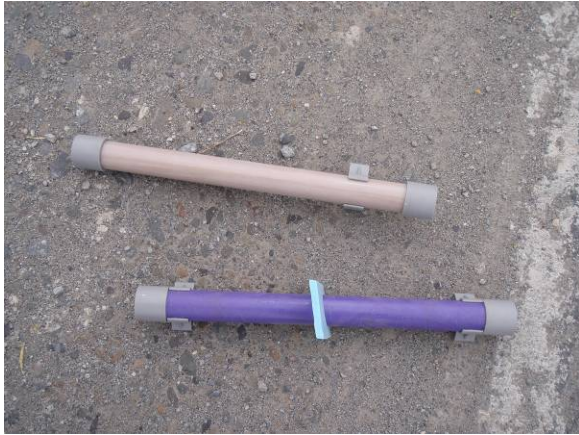
Figure 4. GFRP bar top, epoxy coated bar bottom.

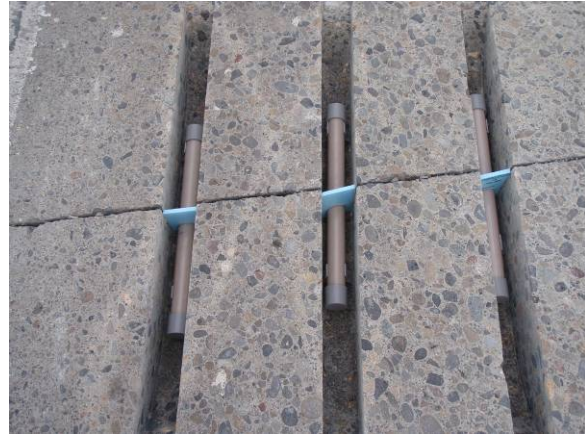
Figure 5. GFRP dowels placed in slots.

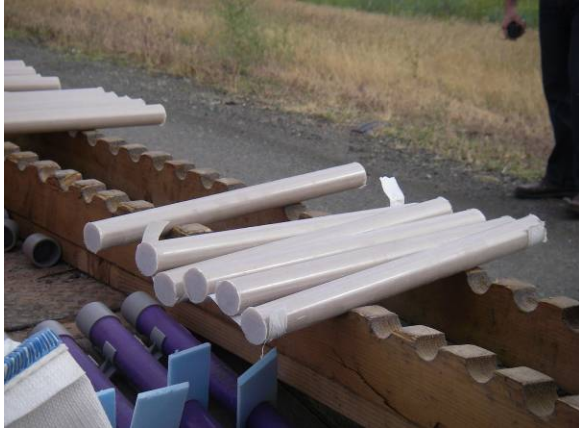
Figure 8. GFRP dowels.

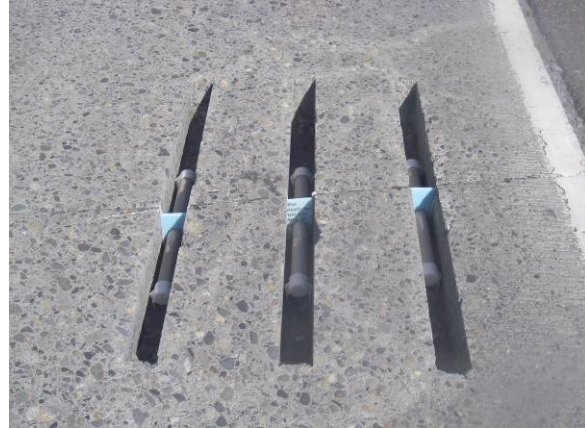
Figure 9. Dowels in slots.

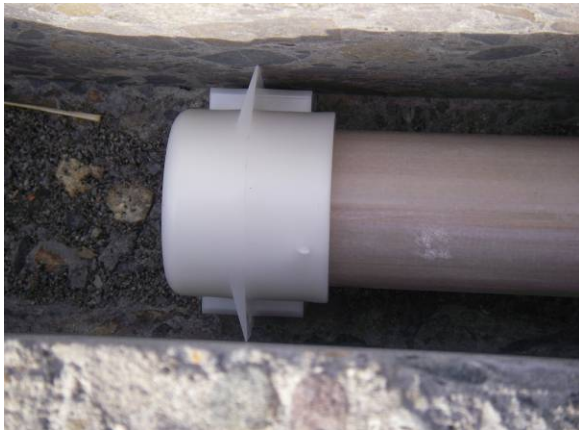
Figure 10. End caps on GFRP dowels.

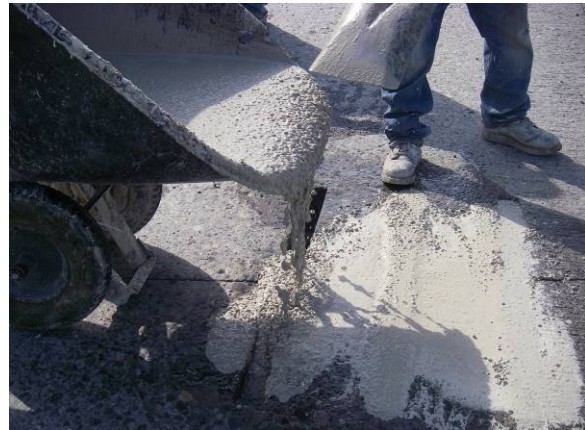
Figure 11. Slot filling.

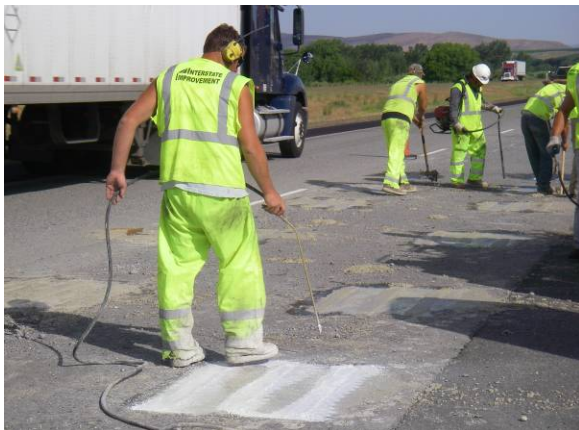
Figure 12. Application of curing compound.

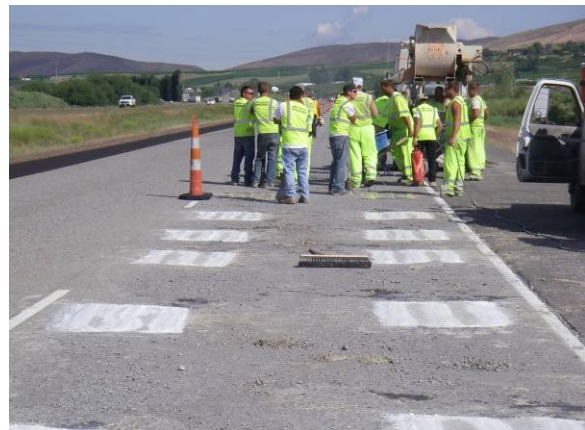
Figure 13. Finished installation prior to diamond grinding to remove faulting.
